MSC-07230

NATIONAL AERONAUTICS AND SPACE ADMINISTRATION

APOLLO 16 MISSION REPORT

MANNED SPACECRAFT CENTER
HOUSTON, TEXAS
AUGUST 1972

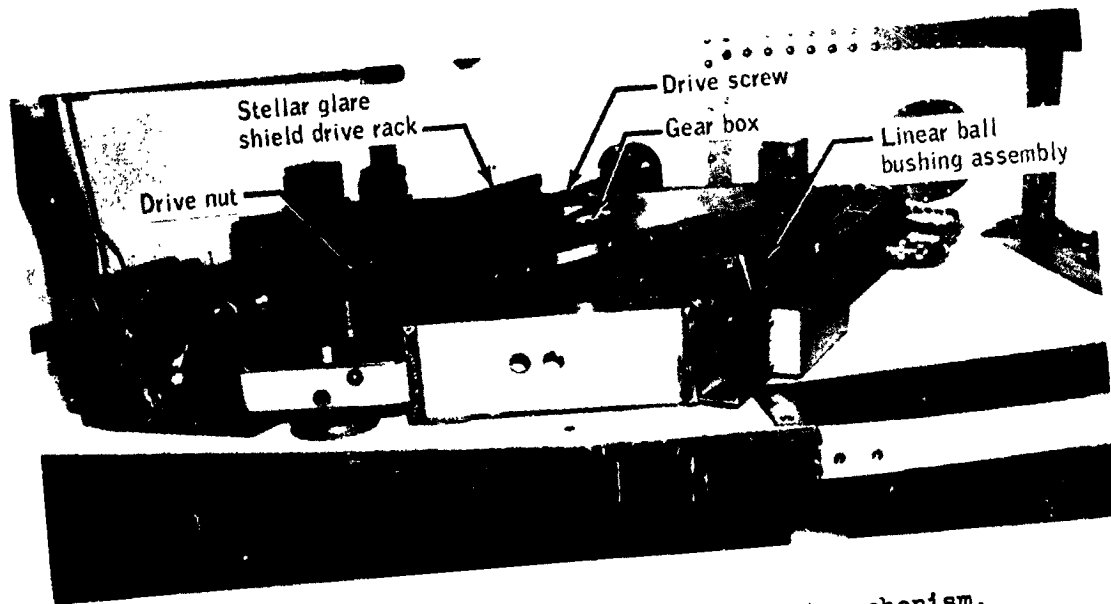
Figure 14-66.- Mapping camera deployment mechanism.

This anomaly is similar to the Apollo 15 problem in that the times of the first extension and retraction were normal and subsequent times were excessive, with some in excess of 4 minutes. In addition, the Apollo 15 camera would not retract after the final (15th) deployment. Subsequent investigations did not isolate a probable cause of that anomaly.

Deployment rails attached to the bottom of the camera slide through ball-bushings that are part of the deployment mechanism (fig. 14-66). Deployment of the camera is accomplished by the drive screw turning within the drive nut, which is bolted to the camera. Friction in this screw-nut drive is minimized through the use of recirculating streams of ball bearings riding between the threads of the nut and screw.

Preflight deployment operations had disclosed a chattering noise in the mechanism when the retraction was aided by the pull of the cable harness to the camera. An analysis of the drive train indicates that a state of dynamic instability may exist in a zero-g environment because of the resultant loss of the damping provided by the deployment rail friction. Simulated zero-g tests are being conducted by suspending the camera with a long cable in order to remove the weight from the rails while maintaining the inertial properties of the camera during the deployment.

A separate anomaly report will be published upon completion of analysis and testing.

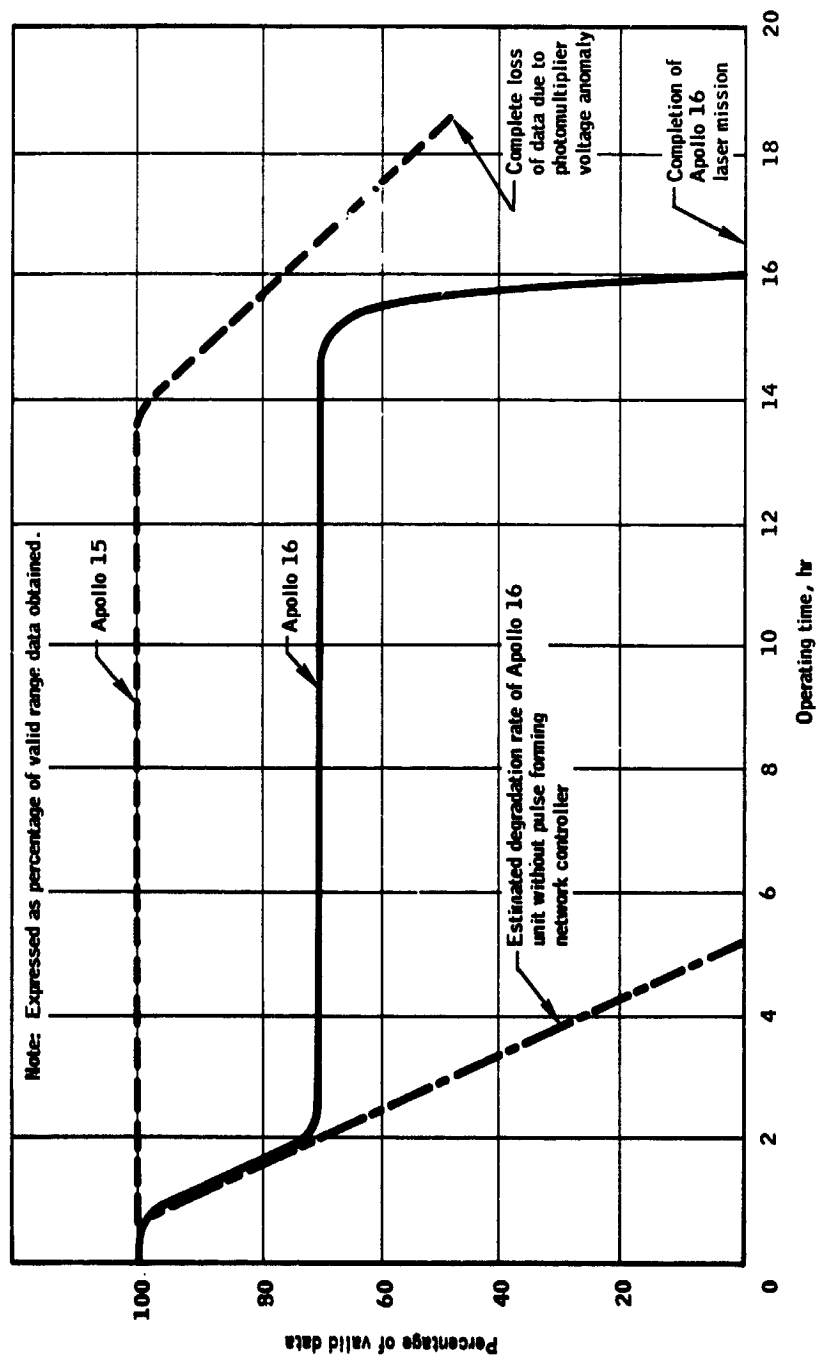
Figure 14-68.- Laser degradation versus operating time.

The laser altimeter performed normally during its first operating period - 41 minutes during lunar revolutions 3 and 4. Evidence of laser degradation began to appear early in the second operating period (revolution 16). The pulse forming network voltage controller began stepping to voltage position 1 (step 0 is the initial setting), and the laser output power, when in step 0, was occasionally too low for ranging - as manifested by altitude readings of zero meters and an overflowing range counter. For this period, altitude data validity was about 68 percent; i.e., approximately 32 percent of the data was "zero".

There were approximately 2400 laser operations (firings) during the mission. The laser output appeared to degrade more rapidly than during the Apollo 15 mission (fig. 14-68) but was compensated by the action of the pulse forming network voltage controller added for this purpose as a result of the Apollo 15 anomaly. The voltage controller consists of a laser power status sensor (photodiode) located inside the laser module and associated circuitry to increase the output of the pulse forming network power supply if the sensed laser power is lower than a pre-established threshold.

The plots of data validity versus operating time in figure 14-68 are approximate in that the effects of laser module temperature and lunar surface illumination have been averaged out. During the first 11 hours of laser operation during Apollo 15, the command and service module was in a highly eccentric orbit which, due to the range limitations of the laser altimeter, caused the loss of approximately 50 percent of the altitude data. Since the data loss was not due to a hardware malfunction, the curve for Apollo 15 is drawn at 100 percent during this period.

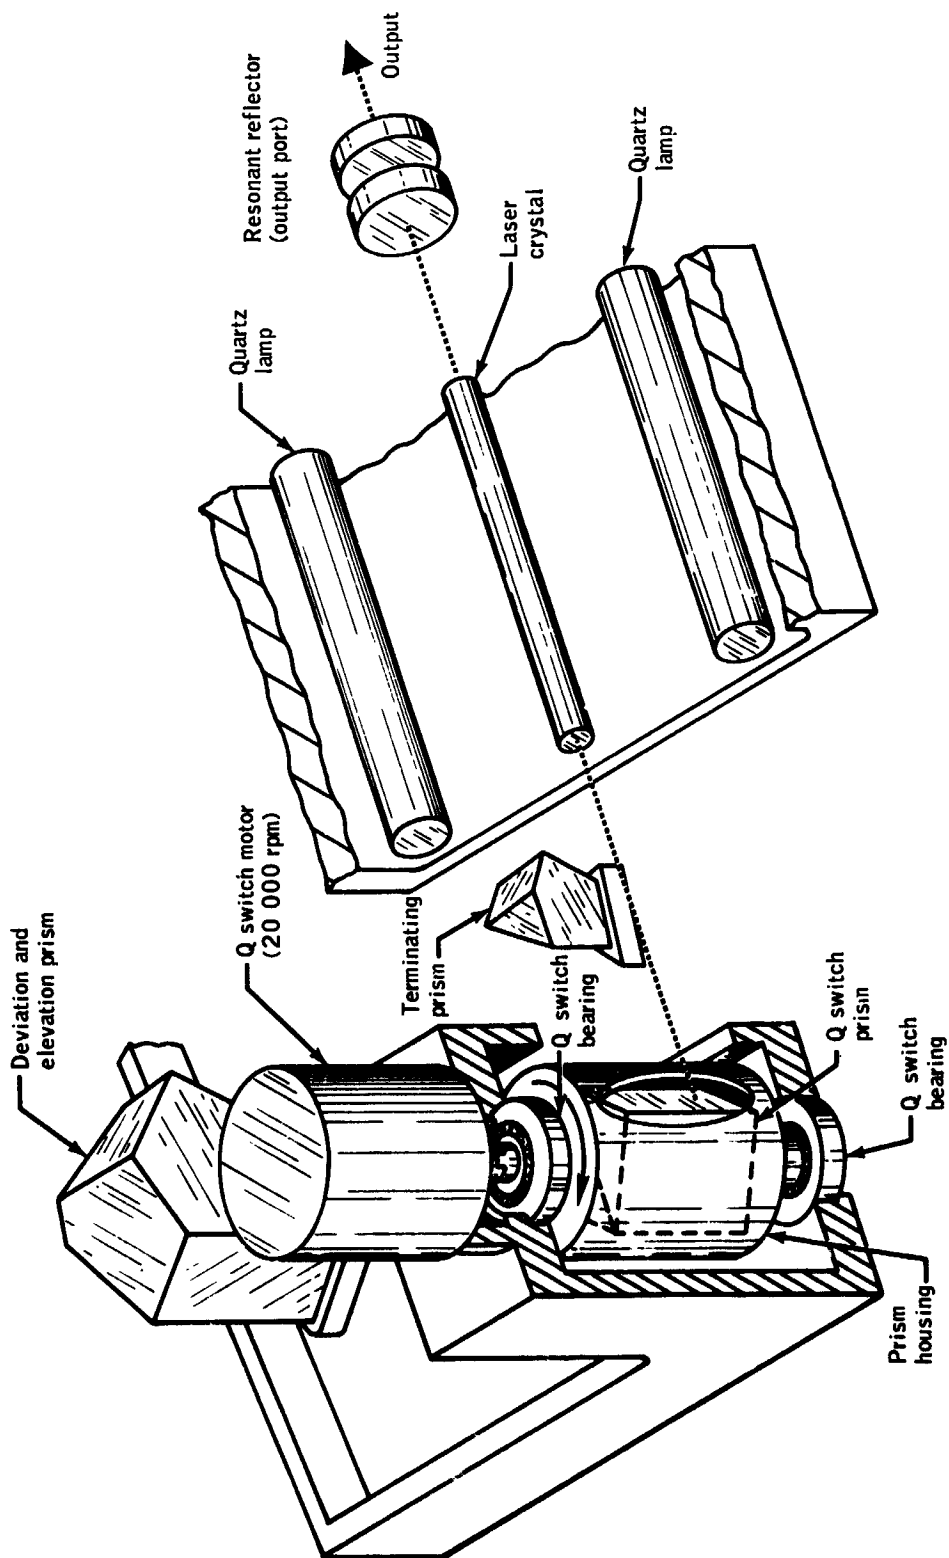
Figure 14-69.- Laser altimeter module light reflection components.

Analysis of the Apollo 15 failure indicated that the most probable cause was contamination of the internal optical surfaces by oil from the Q-switch bearings (fig. 14-69). Consequently, a delta qualification test was performed on a laser module, using new bearings incorporating oil-retainer shields. The qualification test consisted of a 220-hour thermal vacuum test which included a 50.5-hour mission operation timeline. Over 9000 laser firings were performed and the voltage controller had only reached step 4 by the end of the test.

Contamination of the optical surfaces within the laser module is considered to be the most likely cause of the degradation. A secondary cause is the degradation of the flashlamps because of discoloration of the lamp quartz as the result of the repeating high intensity light flashes and impurities in the quartz. The lubricant in the Q-switch motor and rotor bearings is apparently the principal source of contamination. Bearing life tests indicated that elimination of the oil reservoir in the bearings by the use of oil-impregnated bearings does reduce oil migration. Consequently, the Apollo 17 laser module will be modified to incorporate Q-switch bearings with oil-impregnated ball retainers and selection of flashlamps using a high purity quartz which is not as subject to degradation. Cover plates, installed over both access openings to the motor coupling, will complete the enclosure of the motor bearing.

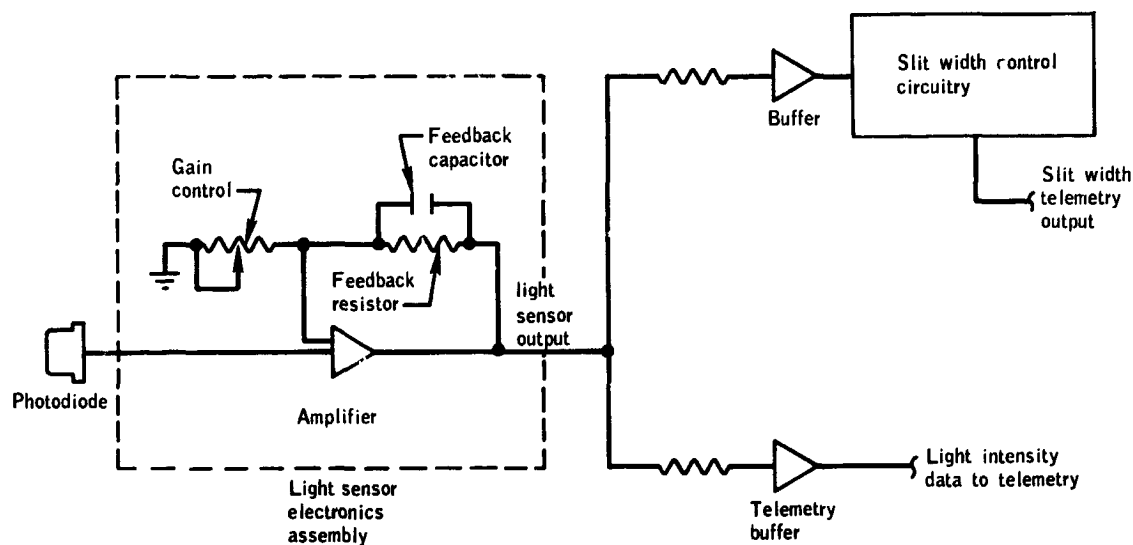
Figure 14-70.- Block diagram of panoramic camera automatic exposure control.

The panoramic camera contains a light sensor and associated circuitry that determines the film exposure. As the scene luminance decreases, the output from the sensor decreases; the resulting signal delivered to the slit width servo causes the exposure slit to widen, thereby automatically increasing the film exposure. The slit width and the light sensor output are both telemetered (fig. 14-70).

Throughout the mission, telemetry indicated that the sensor output was too low, resulting in a slit width that was too wide. Consequently, an overexposure of the film occurred. Based upon preflight brightness calculations and real-time mapping camera exposure data, the degree of overexposure was estimated to be approximately 1-1/2 to 2 f-stops. As a consequence, the film processing was modified to compensate for this degree of overexposure.

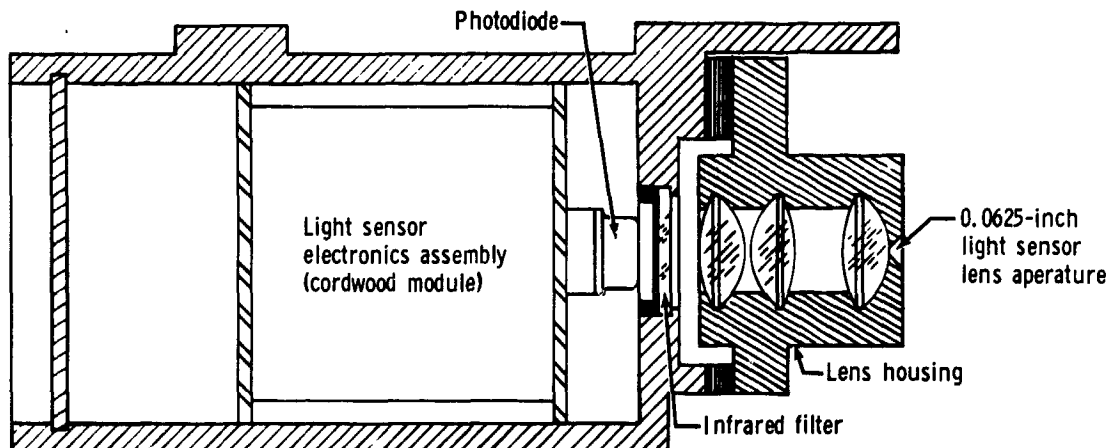
Figure 14-71.- Panoramic camera light sensor assembly.

The problem could have been the result of contamination on the sensor optics or a failure in the light sensor or its associated circuitry (fig. 14-71). Analyses and tests have shown that component open or short circuit failures could not have caused the problem since the amount of overexposure could not be duplicated. Feedback capacitor leakage (equivalent to about 6 megohms leakage resistance), or a decrease in the gain of the photodiode input amplifier (an integrated circuit), or a decrease in photodiode sensitivity, shown in figure 14-70, could have caused the problem. These components, however, have no previous history of these types of failures; therefore, no corrective action will be taken.

A review of data indicates that the problem occurred preflight, at some time between January 5, 1972, and February 25, 1972. The failure was not detected because the test merely ascertained that the light sensor responded to stimulation (a light source placed in front of the sensor). Although sensor output voltage was recorded, no voltage tolerances had been established for the test.

To preclude a similar problem not being detected in ground testing, sensor output voltage limits have been added to the test procedure.

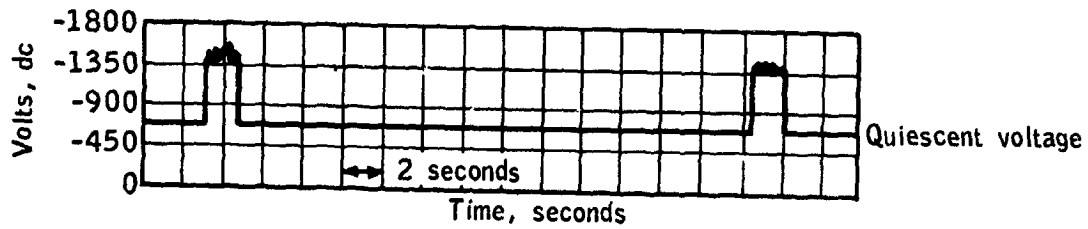
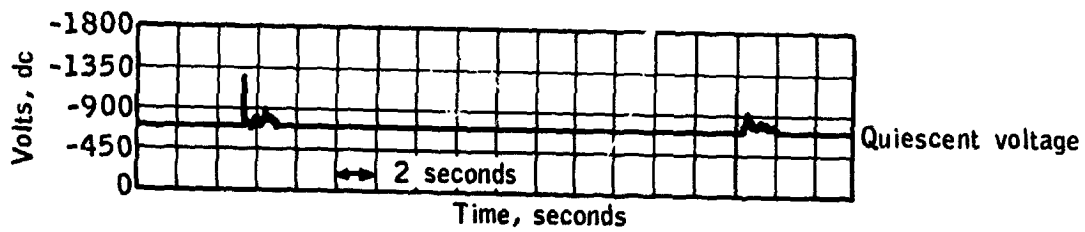
Figure 14-72.- Laser altimeter photomultiplier voltages.

During the revolution-60 operation of the laser altimeter, the high voltage supply for the photomultiplier tube was occasionally erratic. During the next operating period (revolution 63) the erratic behavior became more pronounced (fig. 14-72), and there were several instances when the voltage failed to rise from the quiescent (idling) level.

The photomultiplier tube power supply idles at approximately minus 700 volts during the periods between laser firings. About three-fourths of a second before the laser fires, the power supply is commanded to increase its voltage to the value required for proper photomultiplier tube operation. This value is determined by automatic gain control circuitry (fig. 14-73) that senses the background illumination from the lunar surface. As a result of the automatic gain control action, the photomultiplier tube voltage varies during the mission and appears somewhat noisy, as evidenced by the normal trace (revolution 38) shown in figure 14-72. The revolution-63 trace is unusually erratic, however, and failure to rise from the quiescent level is indicative of anomalous operation.

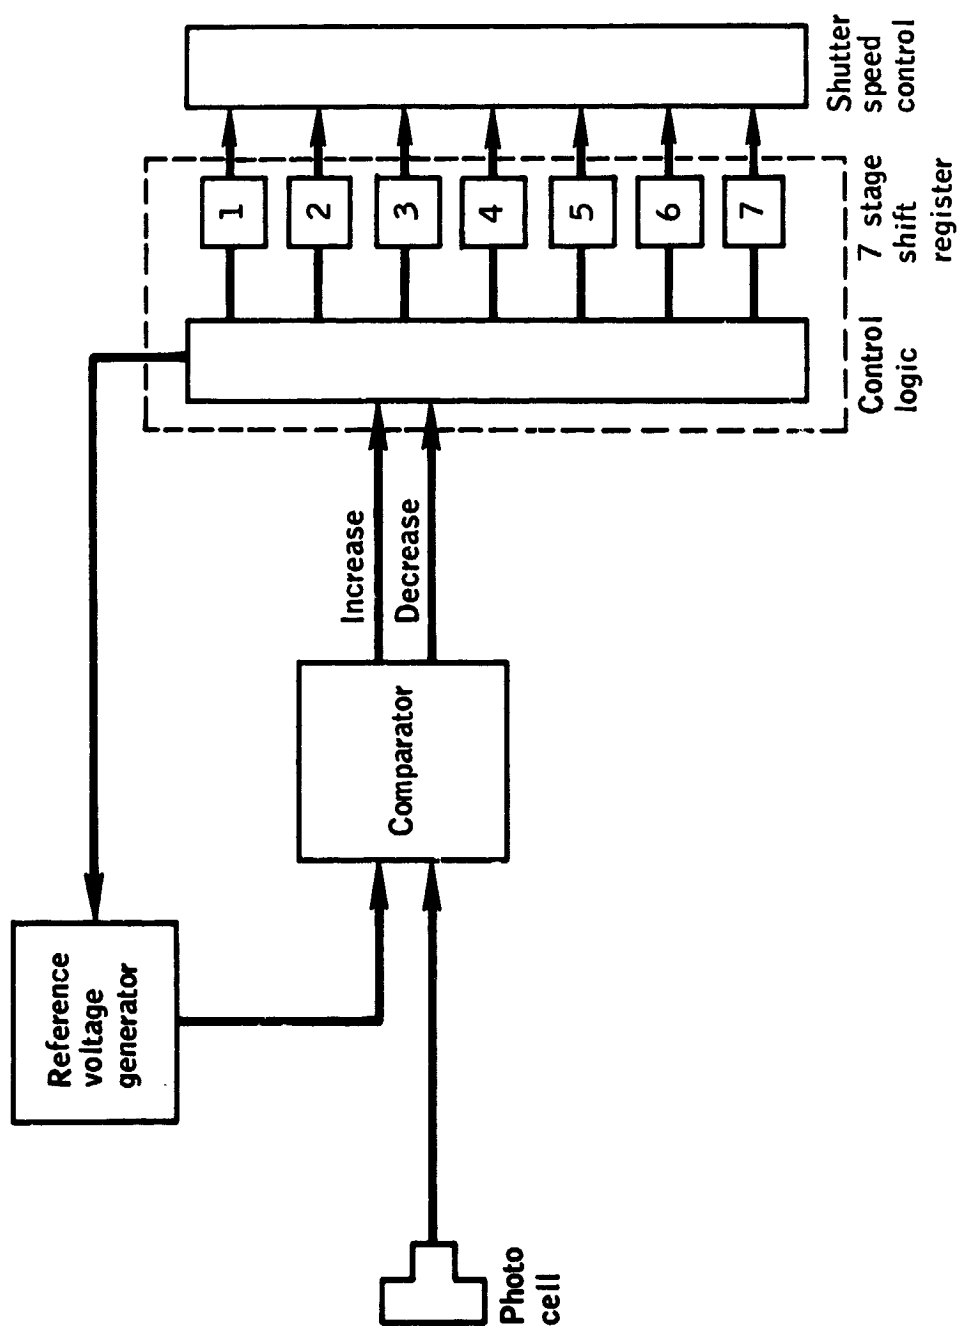
Figure 14-74.- Photocell servosystem.

Shutter speed is controlled by a photo cell which senses the light level in the camera's field of view. The photocell operates in a servo system which controls shutter speed. The photocell servo system consists of the photocell, a comparator, a voltage reference, and a seven-stage shift register, as shown in figure 14-74.

Noise voltage pulses can set or reset (turn on or off) any stage in the register regardless of the condition of any other stage. Thus, more than one stage could be on at the same time, and, in this condition, when the first clocking pulse occurs, the logic would turn stage five on and all other stages off. The remaining five clocking pulses then could still shift to the on stage required by the light level seen by the photocell and no anomalous operation would result. Should the noise pulse occur during the clocking cycle, however, there may not be enough clocking pulses left to shift the on condition back to the required stage. Since the effect of the noise pulse is to shift the on condition to stage five, slow shutter speed and overexposure can be expected to occur more often than fast shutter speed and underexposure.

Noise voltage on the power supplied to the register or generated by some intermittent condition in the camera must have switched one or more stages in the shift register on or off. The camera qualification test results and acceptance tests are adequate. No corrective action is necessary.

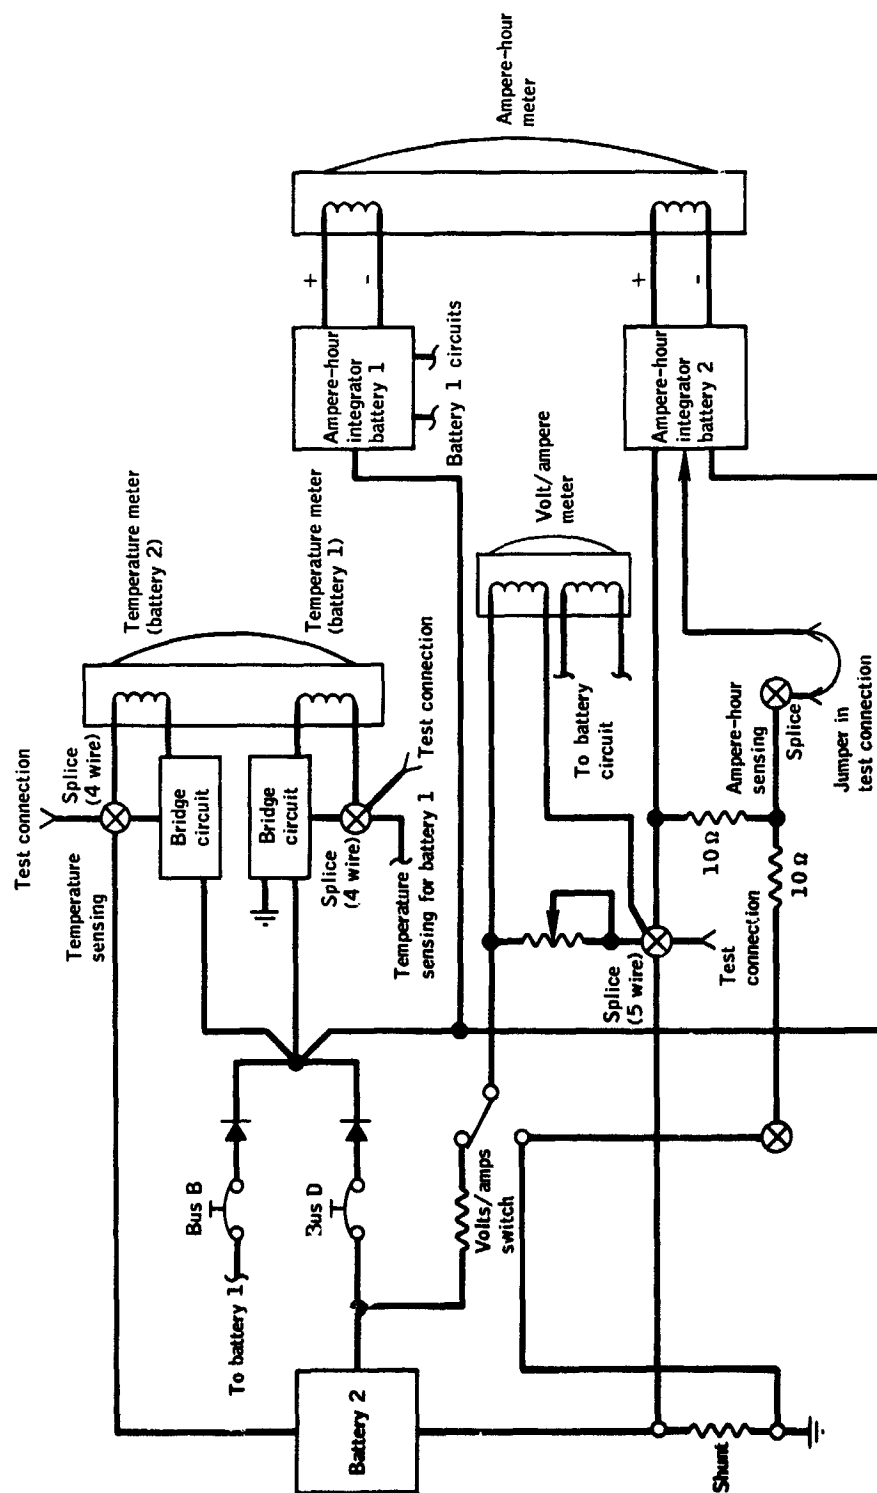
Figure 14-76.- Lunar roving vehicle electrical meter circuitry.

Later, during the second and third extravehicular activities, anomalous conditions were experienced. The battery 2 ampere-hour meter showed an increase in ampere-hours and the battery 1 temperature meter showed a decrease in temperature to off-scale low.

The circuitry associated with the electrical system meters is shown in figure 14-76. Note the multiple wire-crimp splices in the system. The return for the volt/ampere meter is connected to the battery return with a five-wire crimp splice containing one 12-gage wire, one 20-gage wire, and three 22-gage wires. This splice was associated with the electrical modification made on the Apollo 16 lunar roving vehicle at the launch site. An intermittent connection at this splice would explain the volt meter reading off-scale low and then later reading properly. An open connection at this splice would reverse the polarity on the ampere-hour integrator sense line and give a false indication of battery 2 charging as observed during the second and third extravehicular activities (see fig. 14-77). Also, the battery 1 ampere-hour meter indicated a 20-ampere-hour decrease rate which was greater than predicted. However, a review of the data shows that the current readings taken during this period of time were correct and a 20-ampere load was present. Therefore, the ampere-hour integrator for battery 1 was working properly.

Both battery temperatures reading off-scale low and then reading properly could be caused by an intermittent connection at the four-wire splice (fig. 14-76). However, this would require a simultaneous open circuit at two splices initially, which later corrected themselves, and finally, failure of a single splice in the battery 1 temperature circuit.

If no sneak circuit can be identified, the most likely cause of temperature meter anomalies would be the four-wire splice in the temperature meter circuits.

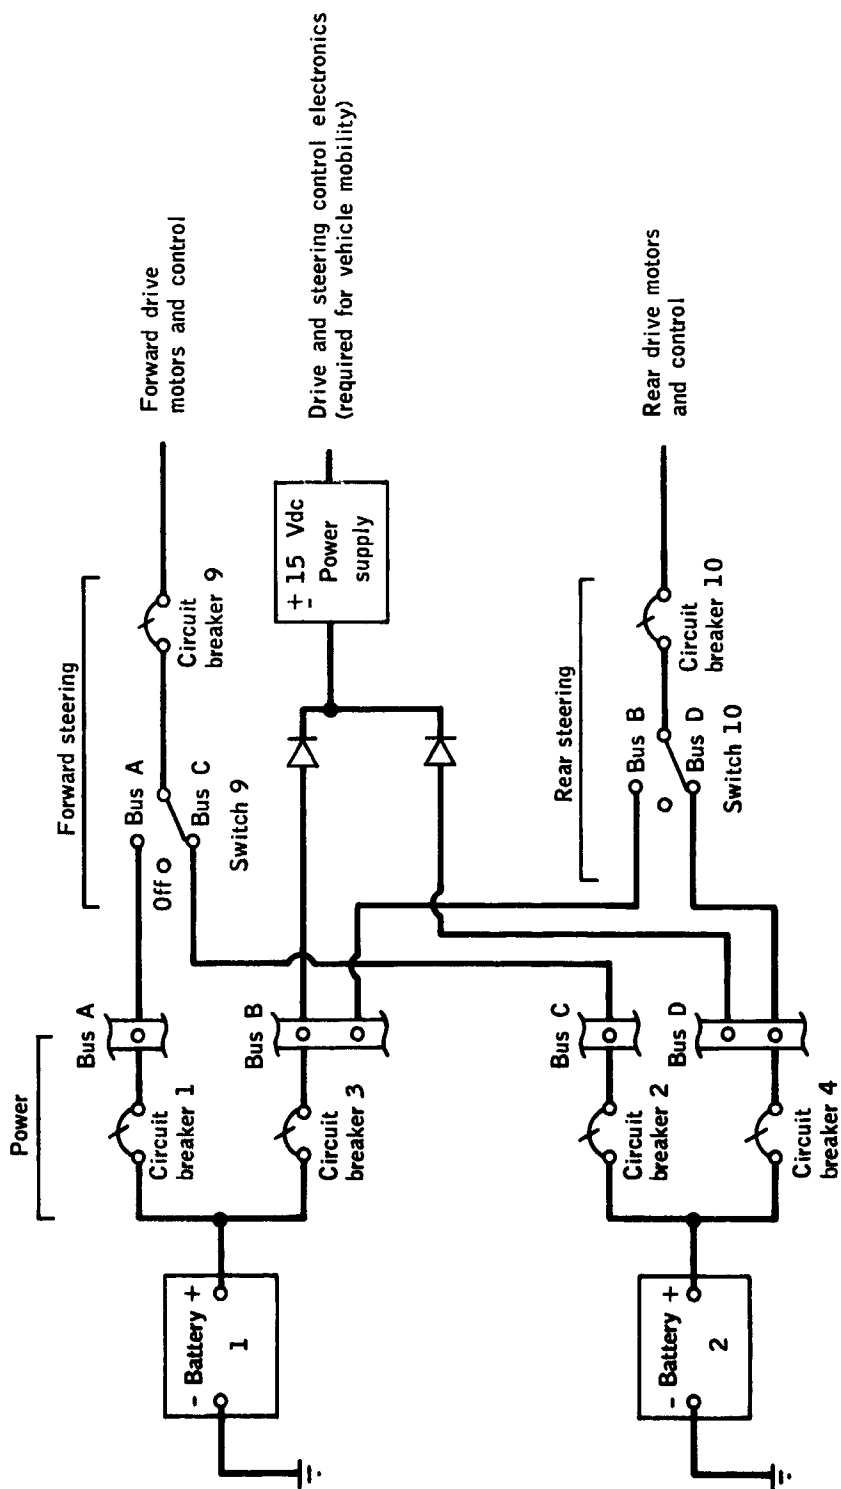
Figure 14-78.- Lunar roving vehicle steering power schematic.

Analysis of troubleshooting procedures initiated by the crew and a review of the switch- and circuit-breaker configuration timeline suggests that no intermittent hardware malfunction existed. An intermittent condition in the rear steering electrical system would explain the anomalous operation, but this is very unlikely because the system exhibited normal performance for the balance of the lunar activity.

Figure 14-78 shows that switch 10, circuit breaker 10, and circuit breakers 3 or 4 must be closed to provide power to the rear steering system. In addition, circuit breakers 3 or 4 must be closed to provide ± 15 Vdc for the drive as well as steering control electronics. Since the vehicle had both mobility and forward steering, at least one of these breakers made contact. Switch 10 was cycled after vehicle motion; however, the rear steering remained inoperative. Circuit breaker 10 could possibly have been open due to some contaminate existing in the breaker.

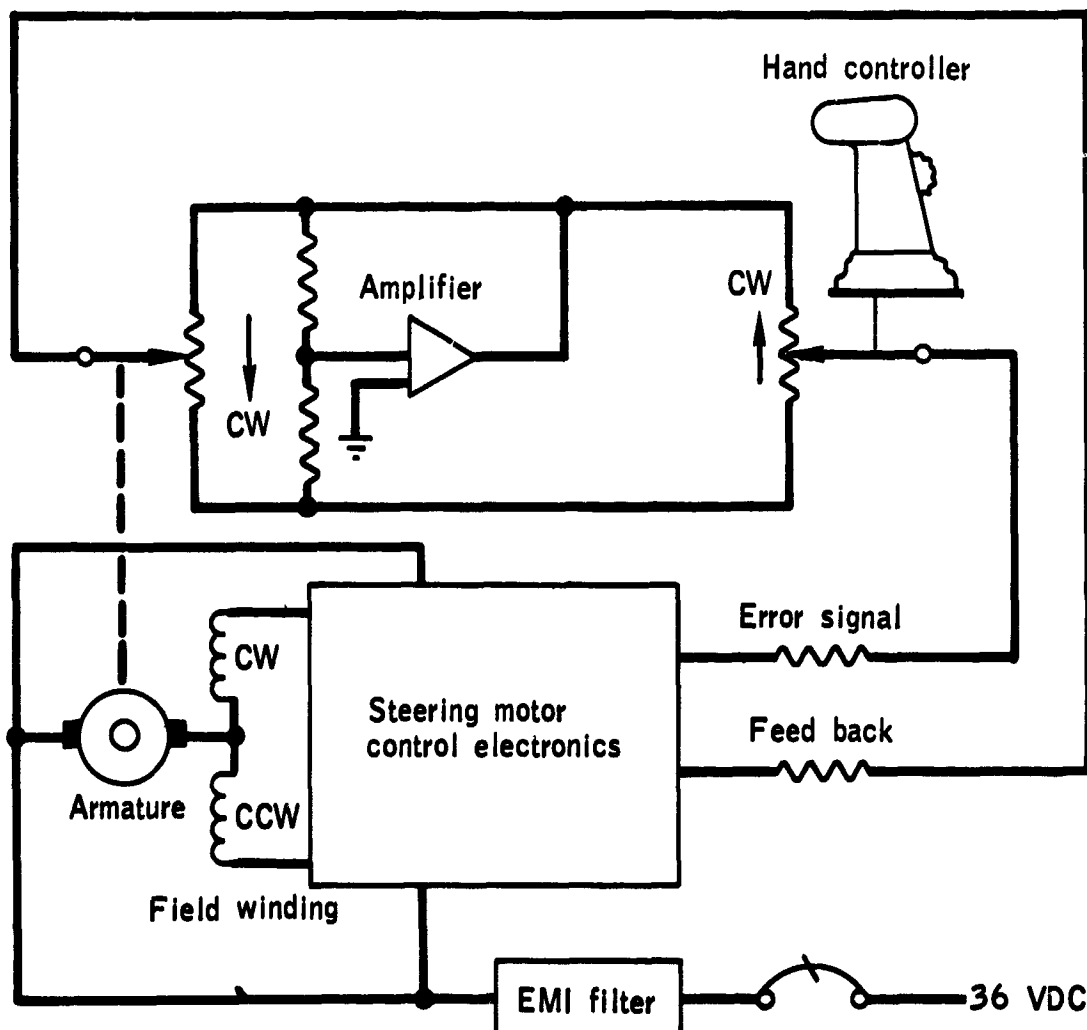
Figure 14-79.- Steering system electrical.

Another possible cause of the anomalous condition is in the steering servo system (fig. 14-79). A signal generated by the hand controller is coupled to the input servo amplifier as an error signal across a bridge. This signal is amplified and applied to the steering motor field coils in a direction determined by the polarity of the input signal which depends upon the direction of the hand controller deflection. The feedback potentiometer is driven by the steering motor in a direction to balance the bridge, thus cancelling the original error signal. A non-conductive lubricant (DC 40), is applied to the wiper and resistive element of the potentiometers to produce smooth operation and reduce noise. At low temperatures, this lubricant could become more viscous and insulate the wiper

from the resistive element. No error signal would then be present at the input to the servo amplifier, although the hand controller was deflected. As the steering electronics heat up, the lubricant becomes less viscous. Exercising the hand controller then cleans the lubricant from the wiper and resistive element, allowing contact to be made. This would account for the anomalous condition. Tests will be conducted to determine the effect of the lubricant on the potentiometers at low temperatures.

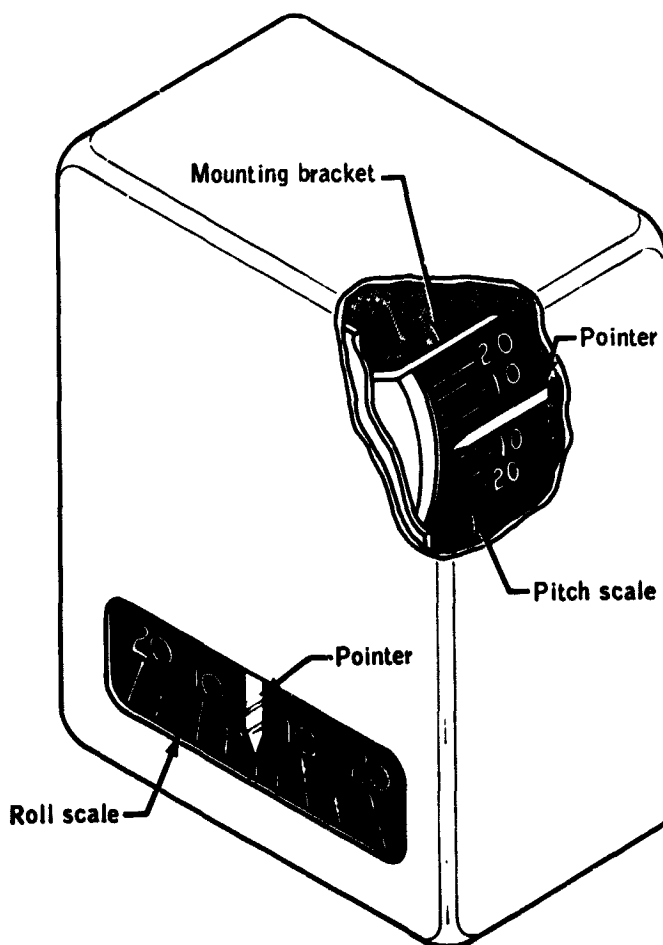
Figure 14-81.- Pitch attitude indicator.

During the second extravehicular activity, the crew reported that the lunar roving vehicle pitch attitude indicator scale had fallen off. The indicator provides a vehicle pitch reference between plus and minus 20 degrees. The loose pitch scale did not impact the mission because the pointer for the indicator continued to work properly and the crew could adequately estimate the vehicle pitch from the pointer position.

The pitch attitude indicator scale is bonded to a bracket (fig. 14-81) which is attached to the indicator case. The scale is constructed of 2024T3

aluminum and the bracket is 6/6 nylon. A comparison of the coefficients of thermal expansion of the materials indicate approximately a 4-to-1 ratio for nylon-to-aluminum. With this expansion ratio, stress factors of safety for an ideal bond are 3 and 4 at temperatures of minus 100° F and plus 250° F, respectively. Although a review of the bonding procedures did not reveal any problems, a flaw most probably existed in the bond and this allowed stress buildup which caused the scale to become unbonded. The crew experienced no difficulty in estimating the pitch angle after the scale became unbonded. The back of the meter case must be machined off to gain access to the scale, and special handling permits must be obtained before working on the meter because of the radioactive materials within the case. For these reasons, no hardware changes will be made for Apollo 17.
